# Manhole Inspection Summary

Manhole # S43M\_\_021MH

Insp Date: **6/5/08 11:14 AM**

**Location** Address: **805 caroline st**

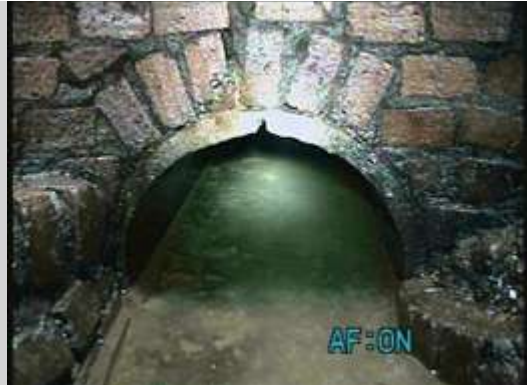
12 O'Clock Outflow

15 in. Circular Gravity Sewer  
Pipe Out @ 12 O'Clock

Pipe Material: Clay ☐ Pipe Lined

Invert Depth: 11.35 (ft.) Flow Characteristics: Slow

Deposits: ☒ None ☐ Mud ☐ Sludge ☐ Debris ☐ Grease

Infiltration: None Pipe Seal Cond: Unknown

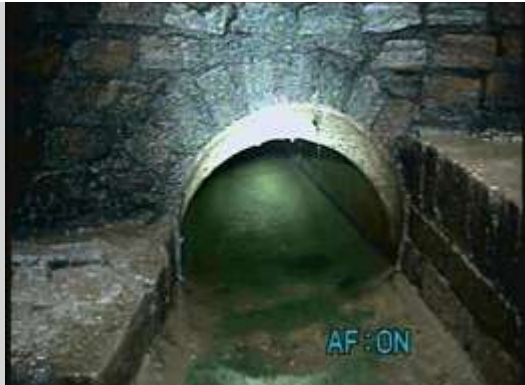
6 O'Clock Inflow

15 in. Circular Gravity Sewer

Pipe In @ 6 O'Clock

Pipe Material: **Clay** ☐ Pipe Lined

Invert Depth: 11.25 (ft.) Flow Characteristics: **Slow**

Deposits: ☒ None ☐ Mud ☐ Sludge ☐ Debris ☐ Grease

Infiltration: **None** Pipe Seal Cond: **Unknown**

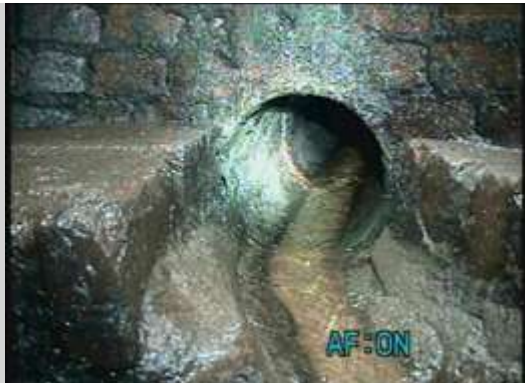
9 O'Clock Inflow

8 in. Circular Gravity Sewer

Pipe In @ 9 O'Clock

Pipe Material: **Clay** ☐ Pipe Lined

Infiltration: **None** Pipe Seal Cond: **Unknown**
